Validation Audit

BC Recreation & Parks Association Community Recreation Facilities Assessment Study

July 2008

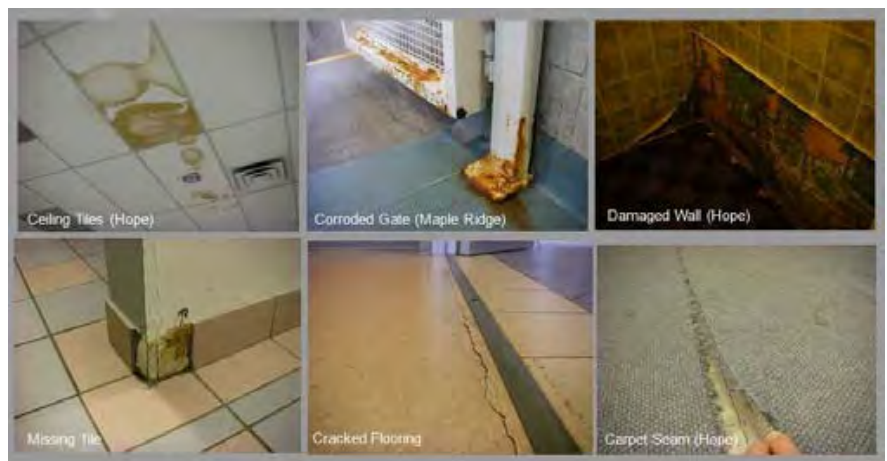
In order to substantiate the findings and recommendations, several photographs were taken of the condition observations at each facility. The figure below includes a few samples of deficiencies in the interior finishes system.

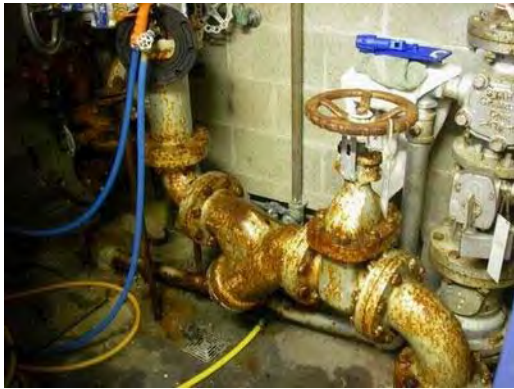
CORRODED HOUSING

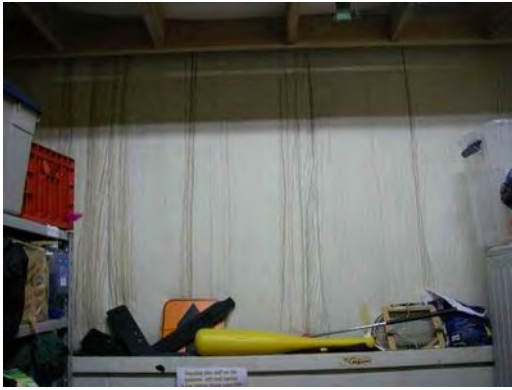
WATER DAMAGED PAINTWORK

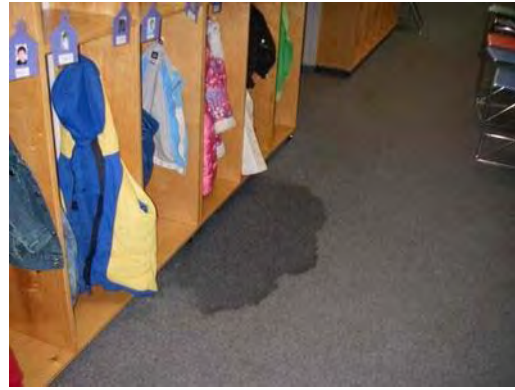
WATER RUNDOWN STAINS
