Validation Audit

BC Recreation & Parks Association Community Recreation Facilities Assessment Study

July 2008

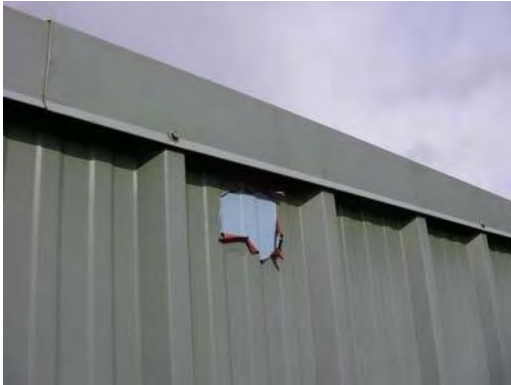
COATING PEELING ON METAL WALL

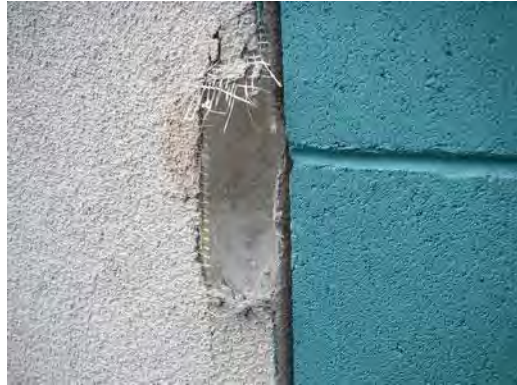
DAMAGED EIFS WALL

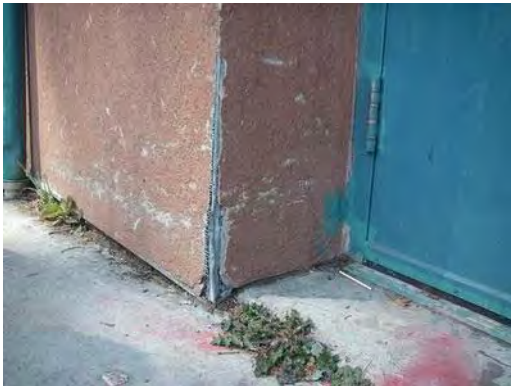
DAMAGED STUCCO WALL

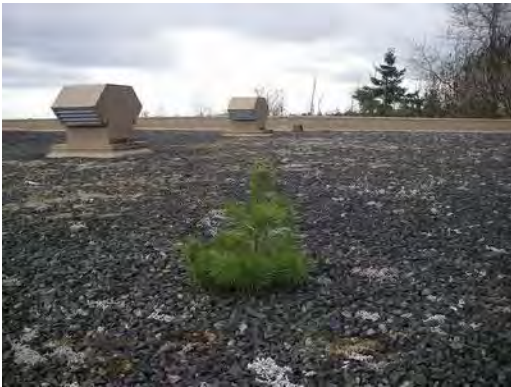
VEGETATION GROWTH ON ROOF

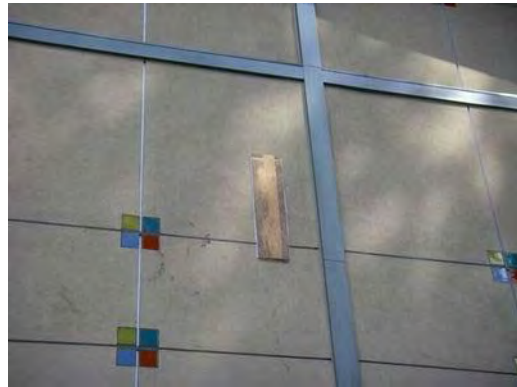
WALL DAMAGED FROM FALLEN TREE

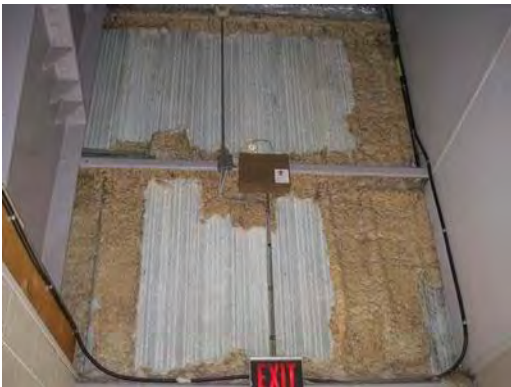
WALL INSULATION MISSING

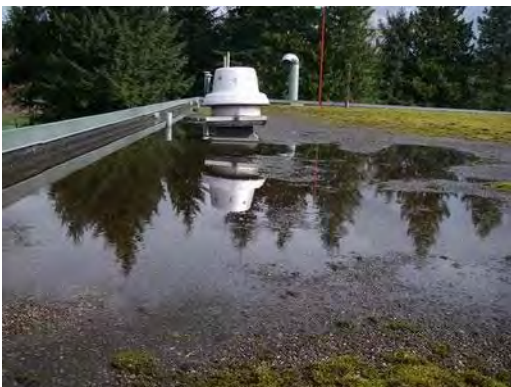
PONDING WATER ON ROOF

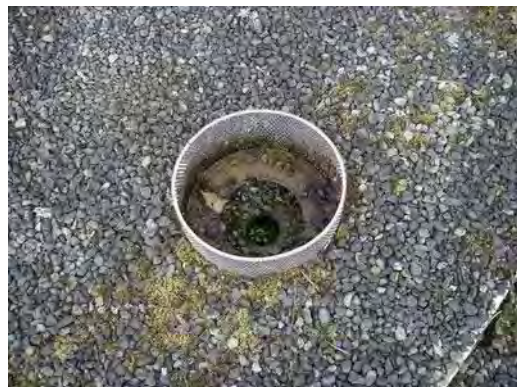
MISSING ROOF DRAIN SCREEN

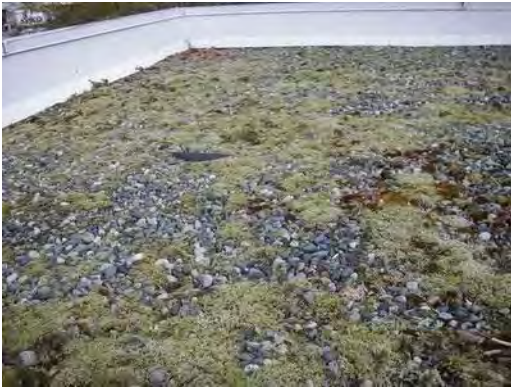
MOSS GROWTH ON ROOF

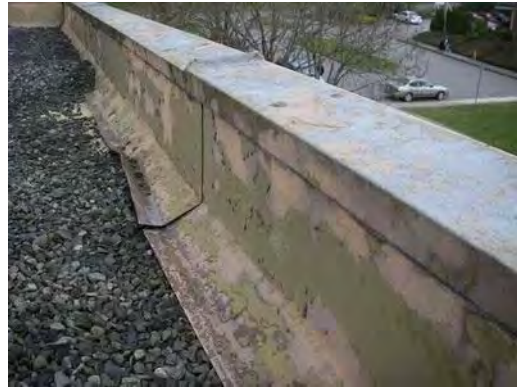
PAINT PEELING ON FLASHING

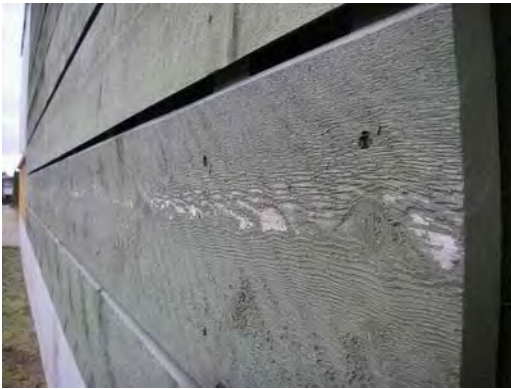
DAMAGED WOOD FASCIA

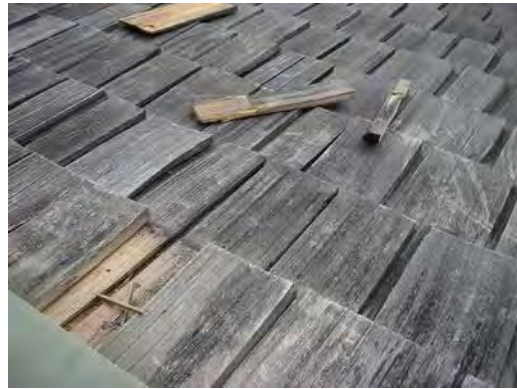
DAMAGED WOOD SHINGLE ROOF

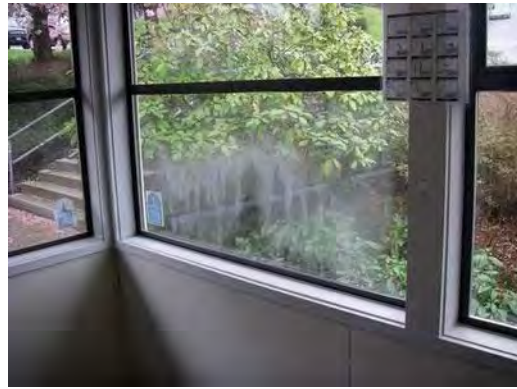
FAILED WINDOW SEAL

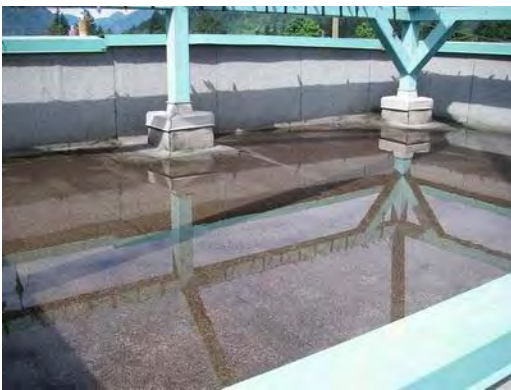
PONDING WATER ON CANOPY

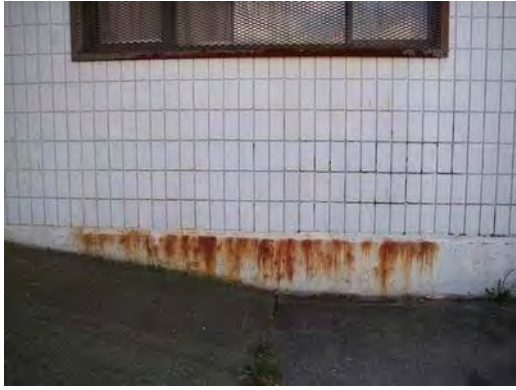
CORROSION STAINS FROM WINDOW

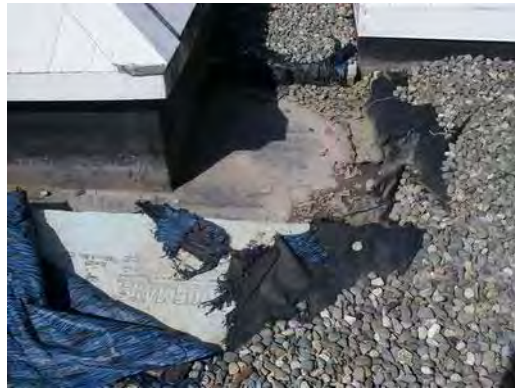
ROOF MEMBRANE EXPOSED

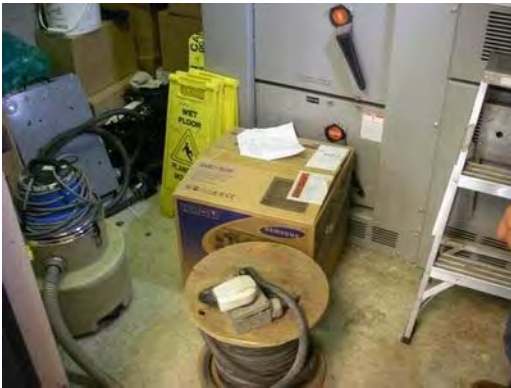
STORAGE IN ELECTRICAL ROOM

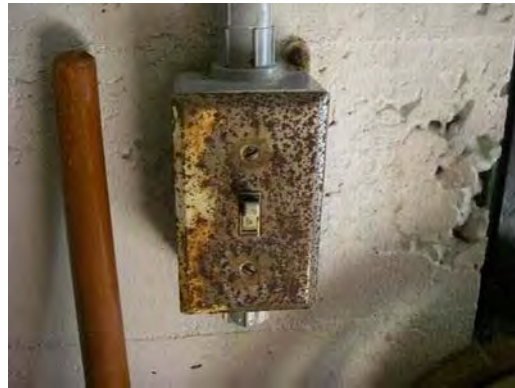
CORRODED LIGHT SWITCH

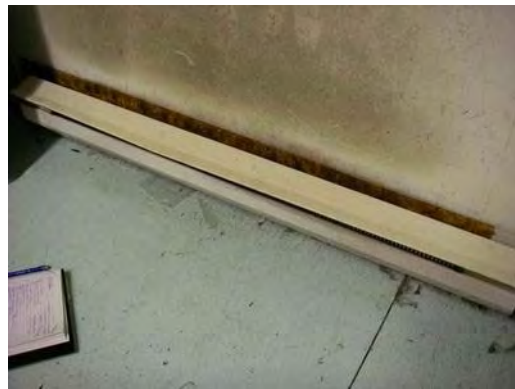
LOOSE BASEBOARD HEATER

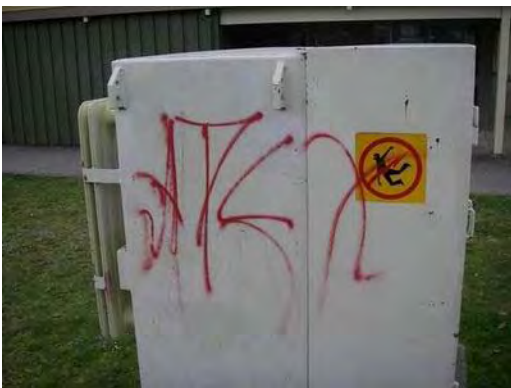
GRAFFITI ON TRANSFORMER

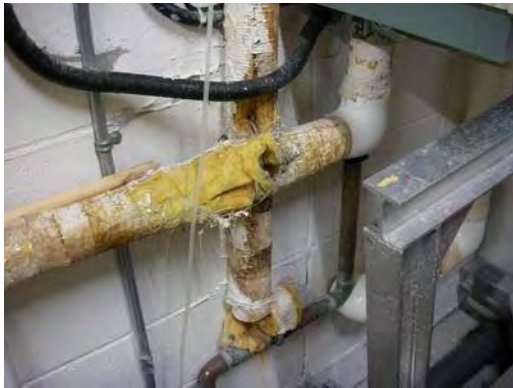
DAMAGED PIPE INSULATION

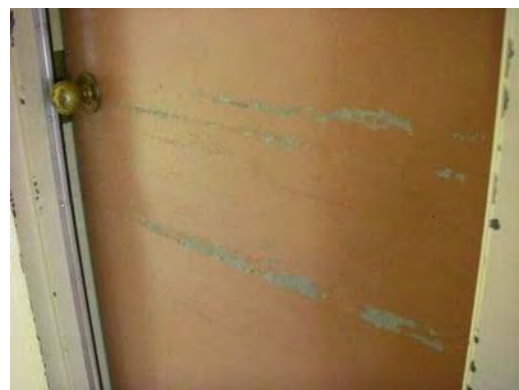
DAMAGED PAINT

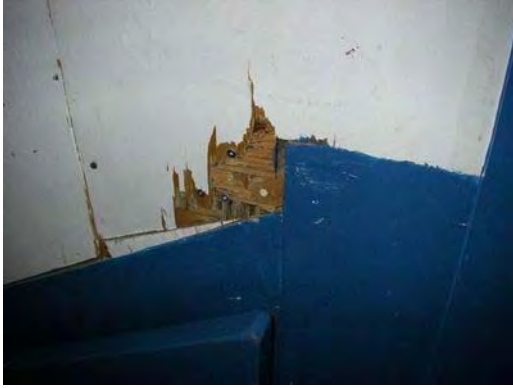
DOOR COATING GOUGED

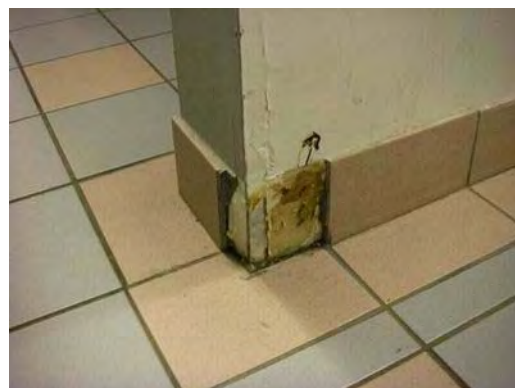
DRYWALL DAMAGED
