Validation Audit

BC Recreation & Parks Association Community Recreation Facilities Assessment Study

July 2008

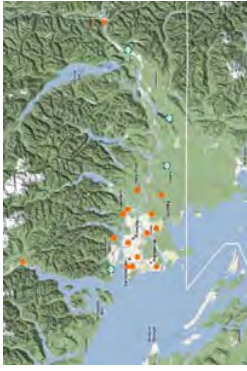
FACILITY CONDITION INDEX (TD-FCI)	4.5% A	COST OF 5 YEAR RENEWALS (RENEWALS)	\$110,000
EXTENDED FACILITY CONDITION INDEX (TD-EFCI)	9.7% A + B	OVERHEAD AND PROFIT (15%) X CONTINGENCY (10%) X CONSULTANT FEES (15%) (SOFT COSTS)	\$50,000
FACILITY NEEDS INDEX (TD-FNI)	72.8% A + B + C	SUM OF RENEWALS (R5)	\$160,000 B
		OBsolescence ESTIMATE ("GET-AHEAD")	\$1,960,000 C
		FUNCTIONAL OBsolescence (FO)

SYSTEM	RATING	SUMMARY OF SYSTEM	SUMMARY OF CONCERNS	SUMMARY OF RECOMMENDATIONS	EST. COST
Structural	4	Foundation system is footings and concrete slab-on-grade. Structural frame consists of packaged steel arch frame, concrete block infill walls and steel girt infill walls above block. Roof structure is steel roof girts. Mezzanine storage is parallel chord wood trusses. There are also steel frame exit stairs.	There is some corrosion on exterior structural steel arch frame. Paint is peeling on steel stairs. Based on a visual review of the exposed structural components and a cursory review of available structural drawings, there were no other significant concerns noted at this time.	Prepare and repaint exterior steel arch frame. Remove peeling paint and repaint steel exit stairs. Provided the building enclosure components (such as roofs, walls and windows) are properly maintained, the underlying, protected structural components are not expected to require any other significant capital expenditures over the next five years. Assemble and retain a package of drawings on site for further condition assessment purposes.	\$50,000 A \$0 B

Building Enclosure	4	Roof is sloped prefinished sheet steel. Walls are concrete block and vertical steel siding. Doors are double out-swing exit doors, steel overhead roll-up doors and aluminum storefront assemblies. Canopies are steel arch frame and prefinished sheet steel and metal frame with fabric.	Cracks through concrete block walls, construction joints are cracked and efflorescence staining is visible. Birds nesting and soiling on vertical steel siding. Double out-swing doors are in poor condition. There is corrosion at the sill of the overhead roll-up doors.	Route out mortar and install sealant to concrete block walls. Clean, seal and recoat concrete block where efflorescence is present. Control bird nesting and clean soiling. Replace double out-swing doors and overhead roll-up doors.	\$0 A \$100,000 B
Electrical	5	The building receives 200 Amp, 208 Volt, 3 phase power from BC Hydro pole mounted transformers. There are distribution panels in the main electrical room and in service rooms around the building. Lighting is predominantly T8 and T12 fluorescent. There are high bay metal halide fixtures and HPS wall pack exterior lights. There is a security system with motion sensors and door sensors. There is a small gas fired electrical generator, which provides emergency power for some of the lights. There is a public address system.	Lack of photo sensors and occupancy sensors and controls on the lighting systems to reduce power consumption.	Budget for photo sensors, timers and occupancy sensors to improve the efficiency of the lighting systems. Conduct infrared scan, review findings and recommendations, and implement necessary corrective measures. Review adequacy of breaker labelling and de-energize panels to test isolation.	\$10,000 A \$10,000 B

Mechanical	5	There are two warm air furnaces (both of which are original). The upper level warm air furnace is to be replaced this year with a packaged air conditioning system for a cost of approximately \$25,000. There are some forced flow electric heaters and gas fired radiant heaters. Domestic hot water is provided by 100 gallon electric hot water heater. There is a hydraulic elevator for handicap access to the mezzanine level.	The main level warm air furnace is original and, as such, is nearing the end of its useful service life. The domestic water heater is also approaching the end of its service life. The elevator is rarely used and the inspection reports by the elevator service contractors were up to date.	Replace the warm air furnace serving the lower level. Replace the domestic hot water heater. Cycle all isolation valves through full operation to test for full isolation and replace seized valves as required.	\$30,000 A \$0 B

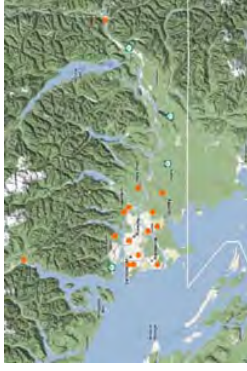
SYSTEM	RATING	SUMMARY OF SYSTEM	SUMMARY OF CONCERNS	SUMMARY OF RECOMMENDATIONS	EST. COST
Structural	4	Foundation system is concrete footings, slab-on-grade and foundation walls on strip footings. Structural frame consists of concrete columns and beams, deep steel roof beam over pool, HSS steel columns, wide-span steel frames over arena, cast-in place concrete bleachers, pre-cast concrete floor slabs and concrete block infill walls. Roof structure is steel OWS) and steel deck. Walls are pre-cast concrete waffle panels. Exit stair and landings are steel frame.	Steel frame exit stairs and landings are exposed, resulting in corrosion. Based on a visual review of the exposed structural components and a cursory review of available structural drawings, there were no other significant concerns noted at this time.	Repaint steel exit stairs. Provided the building enclosure components (such as roofs, walls and windows) are properly maintained, the underlying protected structural components are not expected to require any other significant capital expenditures over the next five years. Assemble and retain a package of drawings on site for further condition assessment purposes.	\$25,000 ^A \$0 ^B

Building Enclosure	3	Roofs are prefinished sheet steel, 2-ply SBS. BUR and inverted with EPDM membrane. Skylights are barrel vault. Walls are deep-rib pre-finished sheet steel cladding, pre-cast concrete waffle panels, concrete masonry units, horizontal wood siding and stucco infill panels. Windows are aluminum curtain-wall. Doors are double out-swing steel exit doors, storefront, glazed steel exit doors and steel overhead roll-up doors. At-grade includes landscape soils and plantings.	2-ply SBS roof has ridges and blisters. BUR roof is aged and in poor condition. Inverted roof is aged and in fair condition. Concrete panel walls have unsealed cracks in reveals. Concrete masonry walls exhibit signs of water penetration and exterior algae growth. Stucco panels are cracked. Windows have some failed sealed units and failed or missing sealant. Double out-swing doors are exposed, dented and dirty with temporary exit stairs. Storefront doors are unprotected and paint is chipping on glazed steel doors. Roll-up doors are dented due to puck damage. Plants are encroaching on cladding.	Repair 2-ply SBS roof, replace BUR roof over arena and maintain inverted roof. Apply sealant to concrete panel walls. Locally recoat and clean concrete masonry walls and replace sealant. Route, seal and recoat stucco walls. Replace sealed units and sealant in windows. Clean double out-swing doors, construct stairs with landing and add head flashing. Construct canopy and head flashing for unprotected storefront doors. Repaint glazed steel doors and replace roll-up doors. Reduce soil level and prune plantings away from walls.	\$1,000,000 ^A \$150,000 ^B

Mechanical	<p>3 Four hot water boilers provide heat for the pool and some parts of the domestic hot water system. Warm air furnace for change room area in the rink and direct gas fired water heater. Five gas fired roof mounted air handling units. Three roof mounted air conditioning units (with gas heat). Gas fired unit heaters in some service rooms. The control system in the building was recently upgraded to DDC and majority of actuators were changed to electronic.</p>	<p>Virtually all the roof top units are original and show signs of environmental degradation. Two of the hot water boilers appear to be nearing the end of their service lives. Ductwork requires cleaning. Peeling paint on rooftop ductwork and above pool deck. Plumbing fixtures lack automatic shutoffs.</p>	<p>Clean ductwork, repaint ductwork where paint has deteriorated and is flaking off. Replace insulation on piping in steam generator room. Replace steam generator. Replace 5 roof mounted gas fired air handling units and 2 air conditioning units. Replace 2 x 400,000 BTUH input hot water boilers. Consider installation of automatic valves on plumbing fixtures. Cycle all isolation valves through full operation to test for full isolation and replace seized valves as required.</p>	<p>\$30,000 A \$180,000 B</p>

Pool	<p>4 The pool facility consists of the main pool, a teaching pool and a spa. There are dedicated gas fired atmospheric boilers that heat the two pools and the spa, including a 1.2 million BTU heater for the main pool. Filtration system is diatomaceous earth (DE). There are several pumps including, a two 5 HP booster pumps, a 2 HP pump, a 7 HP pump, a 10 HP ozone supply pump, and liquid chlorine injectors. Steam generator for the steam room. Pool has 22,000 CFM indoor mounted air handling unit with a hot water coil. DDC control for pool equipment.</p>	<p>Corrosion of stair rungs. Aging steam generator. 3 phase 5HP Jacuzzi booster pump is currently not running and should be replaced as it is difficult to find parts for a pump of this vintage. The heaters for the teaching pool and the spa are both aged and reaching the end of their service lives.</p>	<p>Replace corroded stair rungs in concrete DE tanks. Replace steam generator. Replace 3 phase 5 HP booster pump. Replace the Laars NEPC 400 heaters for both the teaching pool and the spa.</p>	<p>\$30,000 A</p>

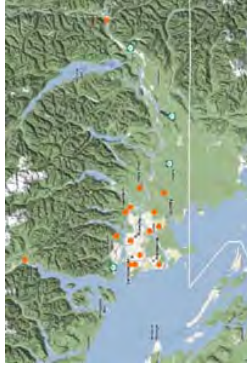
SYSTEM	RATING	SUMMARY OF SYSTEM	SUMMARY OF CONCERNS	SUMMARY OF RECOMMENDATIONS	EST. COST
Structural	5	Foundation system is footings and slab-on-grade. Structural frame is timber post and beam with glue-laminated roof beams. Roof structure is wood decking. Walls are reinforced concrete block masonry.	Based on a visual review of the exposed structural components and a cursory review of available structural drawings, there were no significant concerns noted at this time.	Provided the building enclosure components (such as roofs, walls and windows) are properly maintained, the underlying, protected structural components are not expected to require any significant capital expenditures over the next five years. Assemble and retain a package of drawings on site for further condition assessment purposes.	\$0 A
Building Enclosure	4	Roofs are 2-ply SBS, BUR, and treated cedar shakes over sloped roof. Deck is BUR membrane with insulation and pavers. Sloped skylights are sealed double glazed units in T-bar aluminum frame. Walls are vertical and horizontal wood siding. Windows are aluminum and wood frame with double glazed units. Doors are aluminum frame and wood with wood frame. Sloped canopy with glazing in T-bar aluminum frame.	BUR roof is in poor condition. Vegetation growth on main roof. Deck has poor drainage, active leaks and broken pavers. Skylights are prone to water penetration. Walls and windows are subject to weather exposure. Doors have a lack of weather resistance. Canopy lite is broken. Differential settlement of exterior concrete slabs.	Remove vegetation growth on main roof. Replace BUR roof assembly. Clean and service sloped roof. Replace skylight with improved units. Recoat horizontal and vertical wood siding. Reseal and recoat wood frame windows. Service aluminum windows and all doors. Replace glazing in canopy.	\$300,000 A \$300,000 B

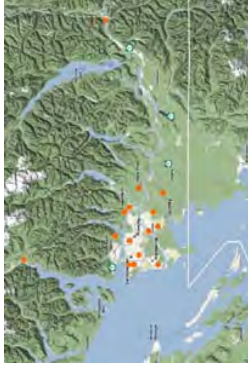
SYSTEM	RATING	SUMMARY OF SYSTEM	SUMMARY OF CONCERNS	SUMMARY OF RECOMMENDATIONS	EST. COST
Structural	5	Foundation system is concrete slab-on-grade and foundation walls on strip footings. Structural frame consists of timber post and beam, wood frame and CMU pilaster and infill walls. Roof structure is OWSJ and steel deck and wood frame roof trusses.	Based on a visual review of the exposed structural components and a cursory review of available structural drawings, there were no significant concerns noted at this time.	Provided the building enclosure components (such as roofs, walls and windows) are properly maintained, the underlying, protected structural components are not expected to require any significant capital expenditures over the next five years. Assemble and retain a package of drawings on site for further condition assessment purposes.	\$0 ^A \$0 ^B
Building Enclosure	3	Roofs are BUR, sloped metal and EPDM membrane. Skylights are acrylic domed. Walls are face-sealed stucco, concrete masonry, giant brick, vertical asphalt shingles, vertical metal siding, tile infill and cedar siding. Windows are single-glazed aluminum, aluminum frame store-front and glazed block. Doors are double out-swing exit doors, pressed steel frame and aluminum slider. Balcony is sheet PVC membrane with top-mounted guardrails. Canopies are metal frame and metal frame with fabric. Landscape soils and plantings are found at-grade.	BUR roof has scuppers for drainage and is leaking. Face-sealed stucco is exposed on chimney. Efflorescence staining on concrete masonry units. Vertical asphalt shingles are inappropriate for application. Single-glazed aluminum windows have poor thermal performance. Evidence of water penetration at metal frame canopy.	Install roof drains to replace scuppers on BUR roof. Replace areas of exposed face-sealed stucco. Install sealant at joints of protected stucco. Clean and seal or coat with elastomeric, areas of concrete masonry and giant bricks. Replace vertical shingles with drained cavity cladding. Remove and over-clad tile infill walls. Replace single glazed windows. Re-detail glazed block with head flashing. Repair roof of canopy and clean up soffit. Replace balcony membrane and install side mounted guardrails.	\$110,000 ^A \$120,000 ^B

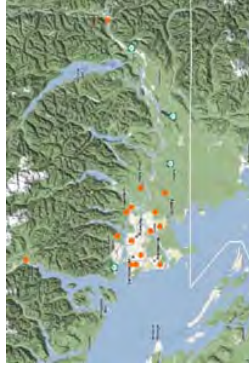
SYSTEM	RATING	SUMMARY OF SYSTEM	SUMMARY OF CONCERNS	SUMMARY OF RECOMMENDATIONS	EST. COST
Structural	5	Foundation system is assumed to be concrete footings under columns, slab-on-grade and suspended floor slab over basement levels. Structural frame is post and beam reinforced concrete and steel, timber truss over library, glue-laminated timber roof beams and structural steel column and beam at new addition. Roof structure is OWSJ and steel deck, as well as structural steel and steel deck.	Based on a visual review of the exposed structural components and a cursory review of available structural drawings, there were no significant concerns noted at this time.	Provided the building enclosure components (such as roofs, walls and windows) are properly maintained, the underlying, protected structural components are not expected to require any significant capital expenditures over the next five years. Assemble and retain a package of drawings on site for further condition assessment purposes.	\$0 A \$0 B

Building Enclosure	3	Roofs are single ply PVC sheet, standing-seam sloped metal and 2-ply SBS. Skylights are aluminum frame curtain wall type. Walls are face-sealed stucco, granite tile, metal siding and exposed architectural concrete. Windows are sloped curtain wall and store-front. Doors are powered solid glass sliders and store-front exit doors. Canopies are structural steel frame and glazing, steel and timber frame and trellis and metal clad steel frame. Plantings and landscaping are found at grade.	There is debris on PVC sheet roof and in the gutters. Sealant at skylights is beginning to fail. Face-sealed stucco is cracked, stained and in distress. Architectural concrete has inadequate water resistance. Sloped curtain wall is dirty and has drainage issues. Storefront doors are exposed, resulting in leakage. Steel frame canopy is covered in debris and algae. Plantings are encroaching on cladding.	Clean the PVC roof and gutters. Remove and replace sealant at skylights. Rehabilitate areas of exposed stucco. Rehabilitate areas of exposed tile. Detail cracks and apply elastomeric coating to architectural concrete. Clean and service sloped curtain-wall. Provide canopies for exposed doors. Clean steel canopy. Prune plantings away from cladding.	\$2,530,000 A \$50,000 B

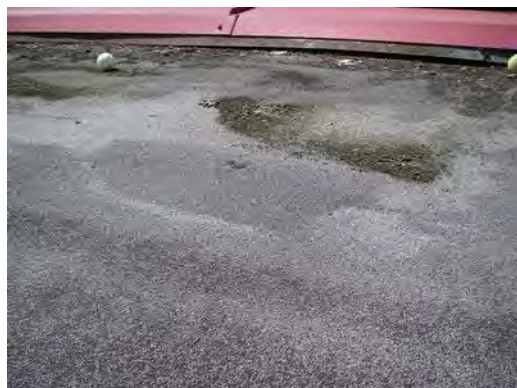
ROOF BLISTERS

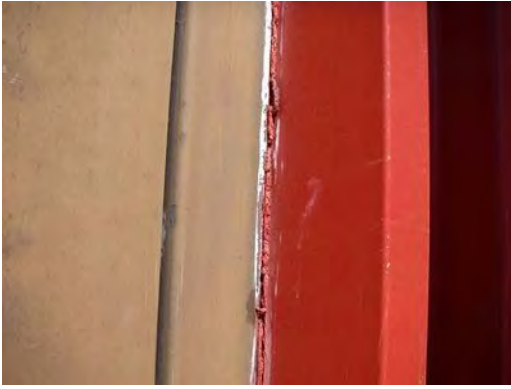
SEALANT FAILURE

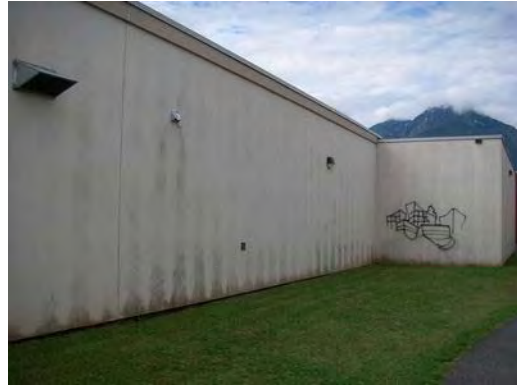
STAINED STUCCO

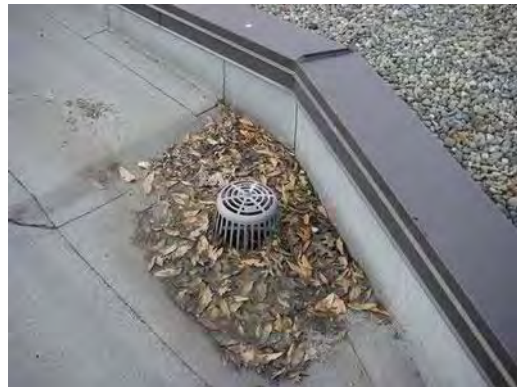
PLUGGED ROOF DRAIN

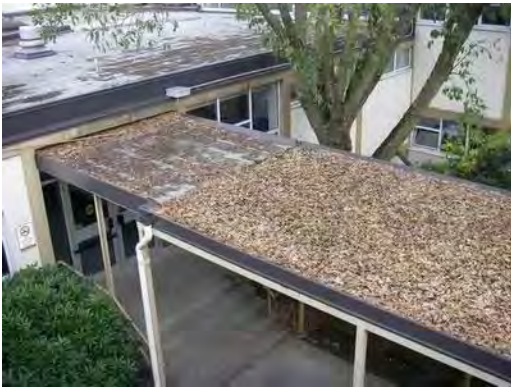
LEAF ACCUMULATION ON ROOF

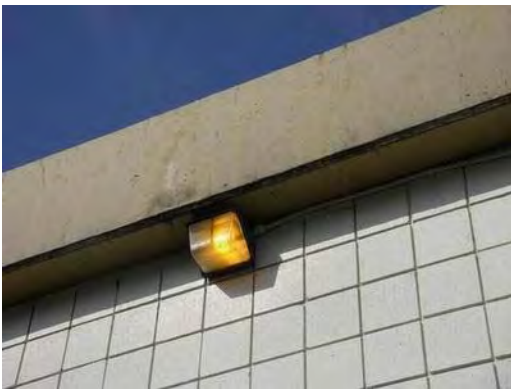
FAULTY TIMER/PHOTOCELL

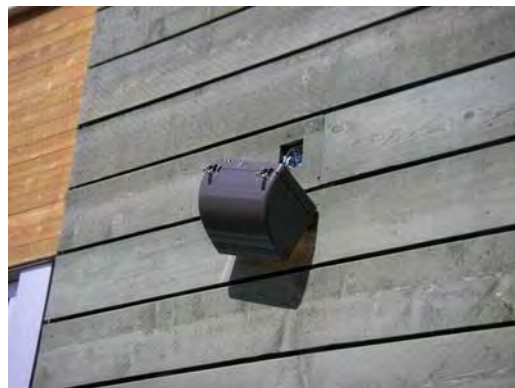
DETACHED LIGHT FIXTURE

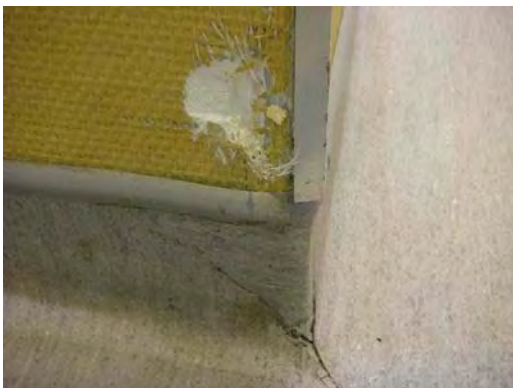
URINE STAINS ON FLOOR
